Report on Conditions in the Great Miami River Near Downtown Dayton, Ohio After Low Dam Modifications and Construction of Kayak Chutes (2017-2018)

Report Author: Jeff Kavanaugh, PhD University of Dayton

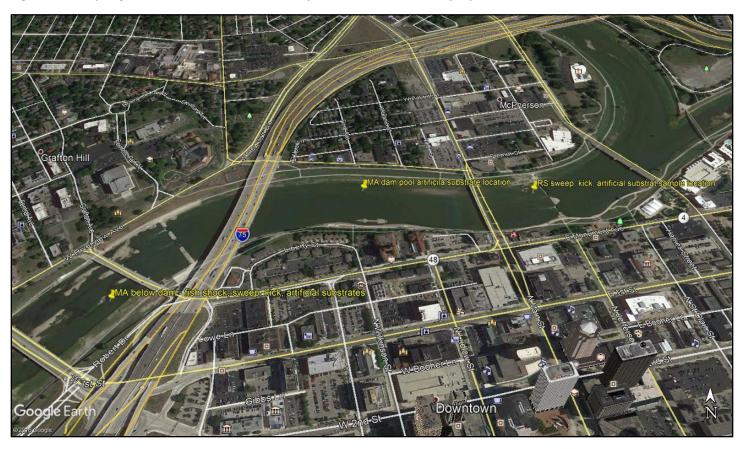
Figure 1. Sampling Locations and dates for 2017 post-dam modification project.

MA-below sweep net, kick net collected on 9/29/17.

MA-below artificial substrates (hester-dendy) collected after six weeks colonization on 9/30/17.

MA-below wading fish shocking conducted on 10/15/17.

MA-above artificial substrates collected on 9/30/17.

RS sweep net, kick net, artificial substrates all collected on 9/30/17.

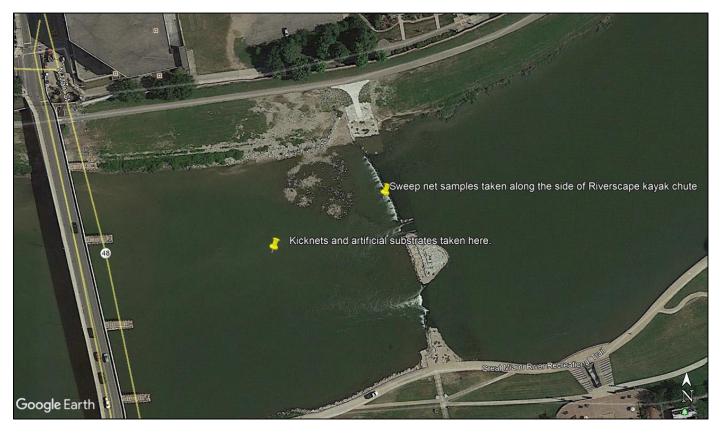
Figure 2. Riverscape (RS) kayak chute sampling locations and dates.

RS sweep net, kick net, artificial substrates all collected on 9/30/17.

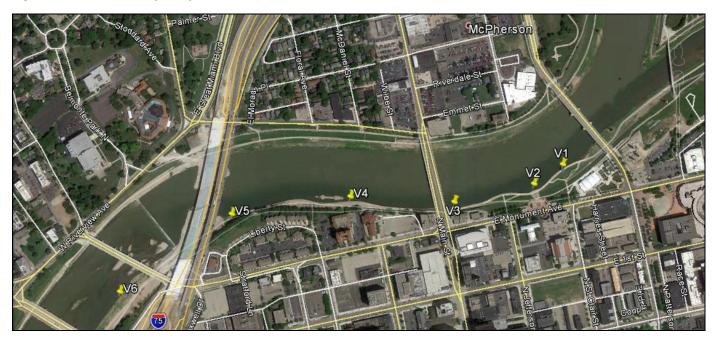
Figure 4. Water velocity sample locations.

<sup>&</sup>lt;sup>a</sup>Location of site "V1" changed from Kavanaugh (2016) to slightly below the gazebo to rule out the effect of water speeding up around the outside bend of the steps leading into the river. As a result the stream velocity was slower in 2017 compared to 2014.

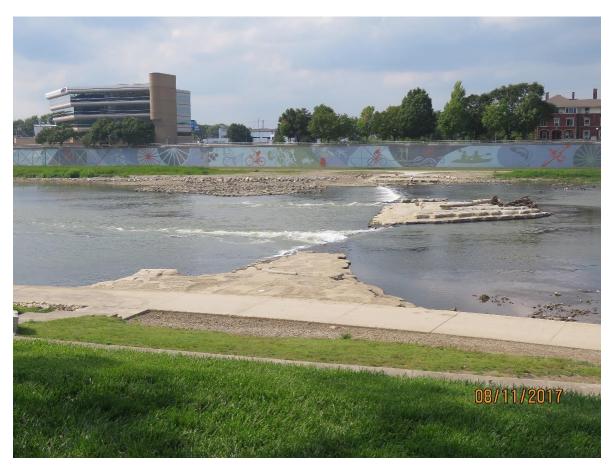
View of Riverscape kayak chute in August, 2017

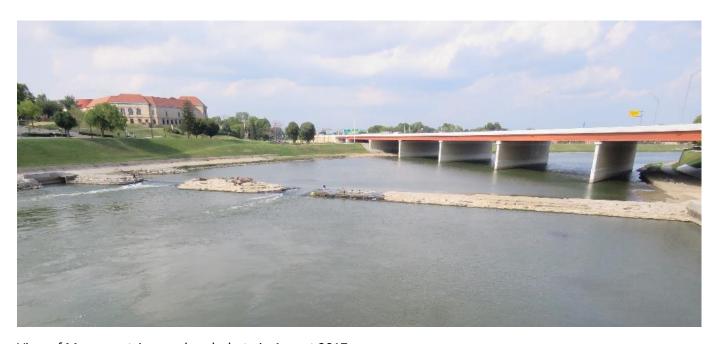
View of Monument Avenue kayak chute in August 2017.

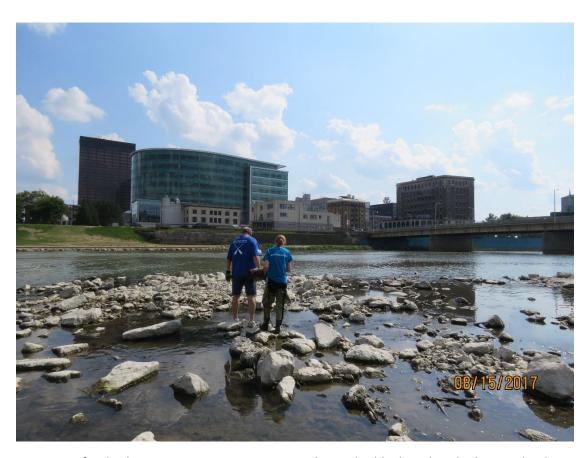
Setting artificial substrates in August 2017. Note the cinder block tied to the hester-dendys.
