Pervious Pavers and Rain Gardens Filter Pollutants

PROJECT DESCRIPTION

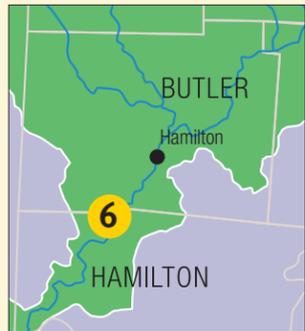
Far right: Water quality samples are collected from the Heritage Park pervious parking area.

The project was monitored monthly before, during, and after construction. Both the pervious and impervious parking areas were monitored to determine a difference in the quality and quantity of runoff that flowed from the different parking surfaces. Research showed that both the rain garden and pervious pavers allowed stormwater to infiltrate the ground, reducing and delaying the amount of pollution that runs to nearby streams and rivers.

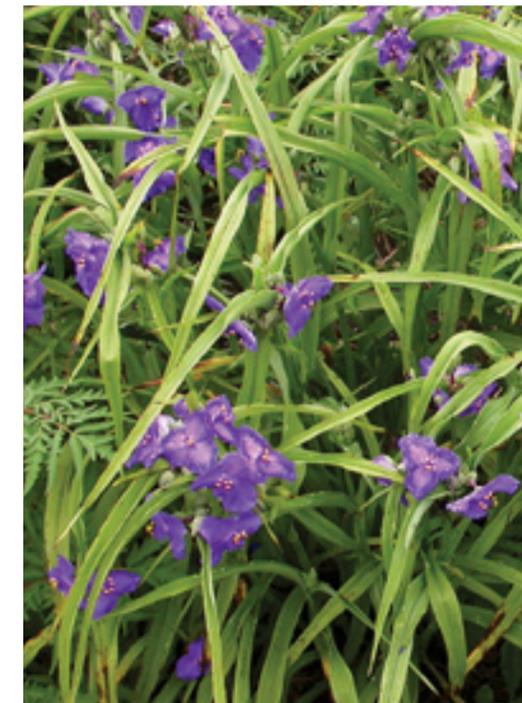
Twenty-seven species of native grasses and spring-flowering perennials were planted around the pervious parking lot and in the rain garden, providing an important habitat for animals, and a burst of spring color for park visitors.

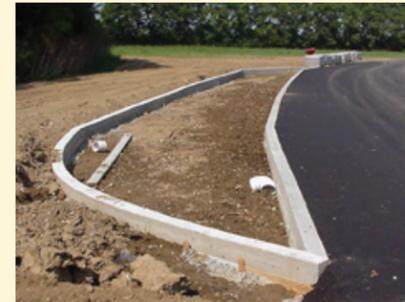
Heritage Park's parking area being prepared for pervious pavers.

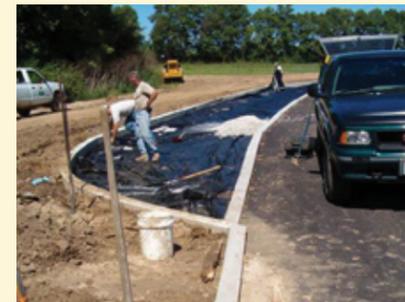
Geotextile is installed in parking area.

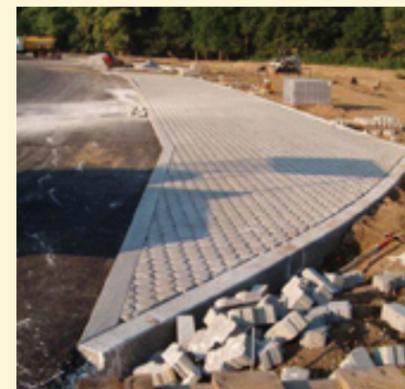
Pervious brick pavers are installed to allow runoff to seep into the ground.

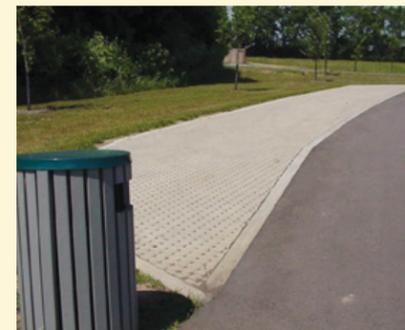
Completed parking area.

The pervious parking area cost \$16,500 for labor and materials, excluding curbs and excavation—\$12.70 per square foot (approximately). The rain garden cost approximately \$15,000 excluding donated labor and materials.
